2014-06-04

DRDC-RDDC-2014-L96

Produced for: Marine Systems Engineering Officer, HMCS PRESERVER.

Inspection of three forged wire rope clips from the port 15 tonne crane aboard HMCS PRESERVER

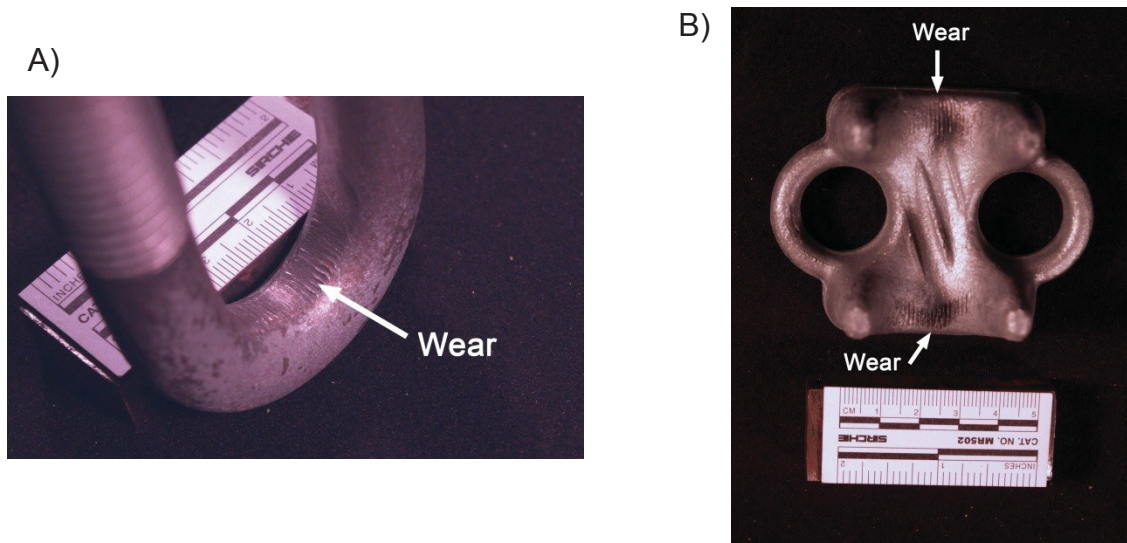
Figure 3: Examples of wear on the A) the U-bolt and B) the base of the forged wire rope clamps.

Wear was visible in the U-bolt and base of all three clamps, as shown in **Figure 3**. The lack of corrosion on the worn areas indicated that the damage occurred recently. The wear surfaces were consistent with what would be expected to occur when the cable pulled through the clamps.

It is recommended that all of the forged wire rope clips in the crane assembly be inspected, to confirm that the U-bolt side of the clips are on the cut-end of the crane and the torque on the nuts is correct. Periodically testing the nuts to ensure the torque is correct could prevent similar failures in the future.

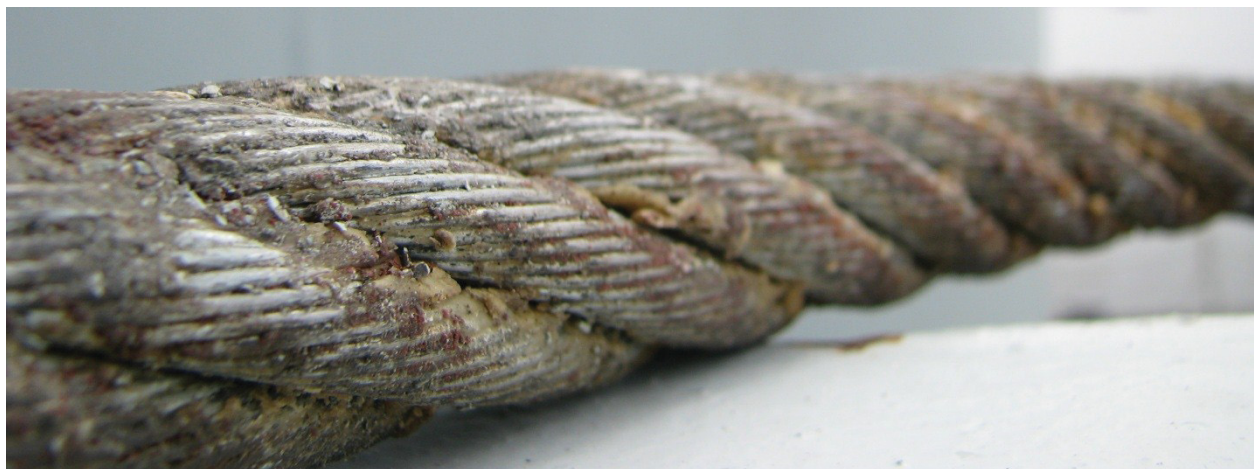
An *in-situ* visual inspection was conducted on the section of the cable involved with the failure. Certain features on the cable, such as broken strands or wear, could indicate the cause of the failure [Ref C]. The inspection was conducted to see if there were any signs of corrosion, wear, broken strands or strand protrusions that would indicate the cause of the failure. The cable appeared to be in good shape: No strands were broken or protruded; wear and corrosion were minimal. **Figure 4** shows section of the cable with the most corrosion. It can be seen that the corrosion is minimal, and has not caused any of the exterior strands to fracture.

Figure 4: Example of mild corrosion on the cable.
